BUILDING 2019

CONDITION SURVEY DATA SHEET

CONDITION SURVEY

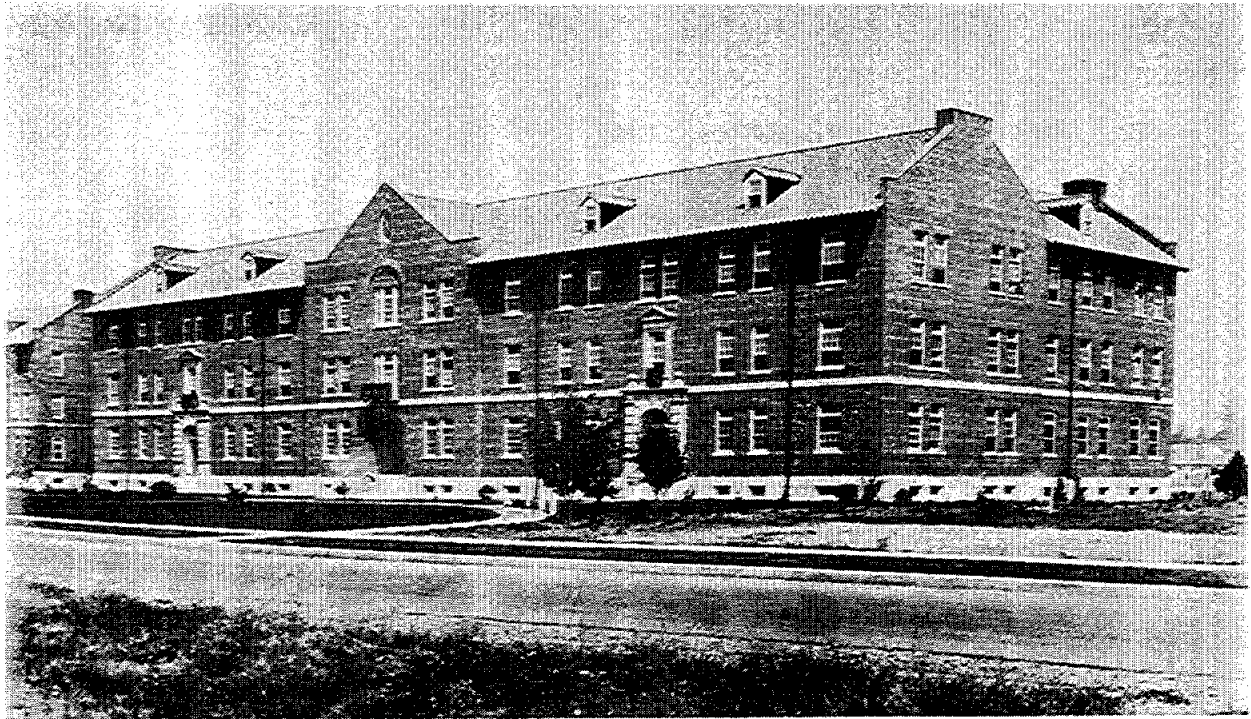
Building 2019 (formerly 400) was built in 1927 as a company barracks and now serves as offices. The three-story E-shaped building is based on standardized Office of Quartermaster General plans in a Colonial Revival style with stone-capped parapeted gable ends including internal chimneys. The central entrance is emphasized by a low-relief pavilion and parapet including oval window, arched entryway, and wrought-iron balcony, while the flanking entries have ornamental stone surrounds. The concrete post-and-slab structural system is sheathed with infill hollow-tile and brick facing exterior walls; the frame roof is covered with tile and includes gabled dormers. The central wing to the rear is a freestanding one-story unit with a distinctive arched window.

The character of the building is established by its overall symmetry, the rhythmic consistency of the 6/6-light windows with transoms, the prominent entryway detailing, and the tile roof. The building is one of the most historically intact. Although some of the interior spaces have been partitioned, the detailing throughout, including panel doors, remains original.
